DOT/FAA/AR-00/18

Development of Supplemental Inspection Report for the Fairchild Metro SA226 and SA227 Airplane

April 2000

Final Report

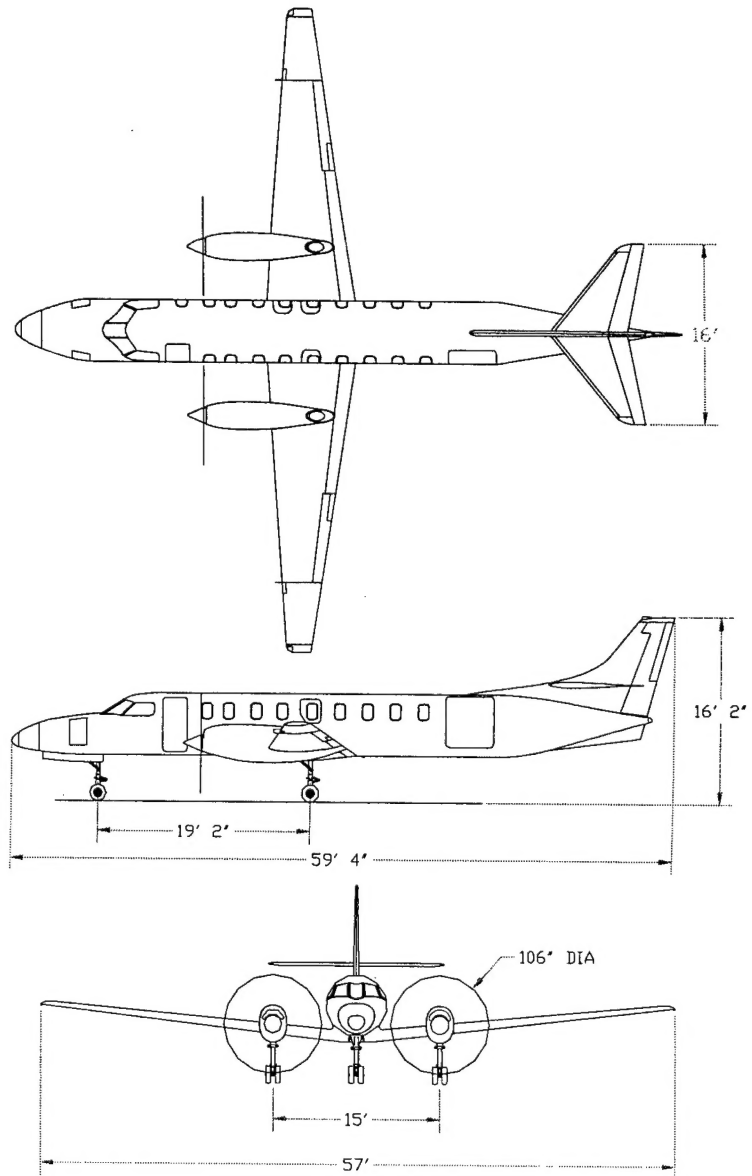
FIGURE 1. SA227 BASIC GEOMETRY

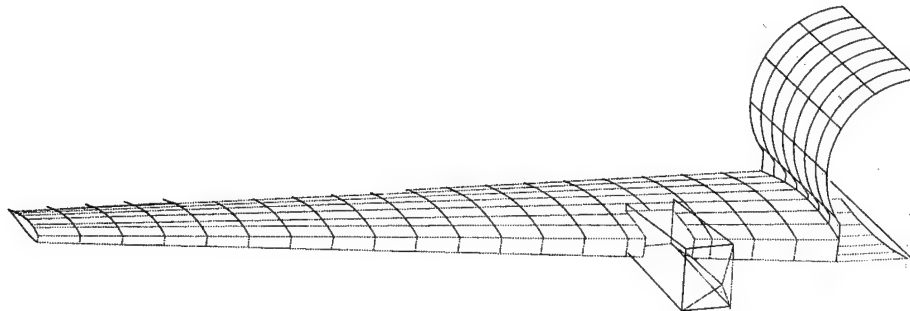
FIGURE 2. SA227 WING FINITE ELEMENT MODEL

The wing finite element model shown in figure 2 was used to analyze the SA227 wing [1]. The results were checked during the SA227 wing static test [2] and shown to be within about 1% of the measured stress for the more heavily loaded portions of the wing. The finite element model was therefore used as an aid for selecting critical PSE areas and determining stress at locations on the wing other than strain gage locations.

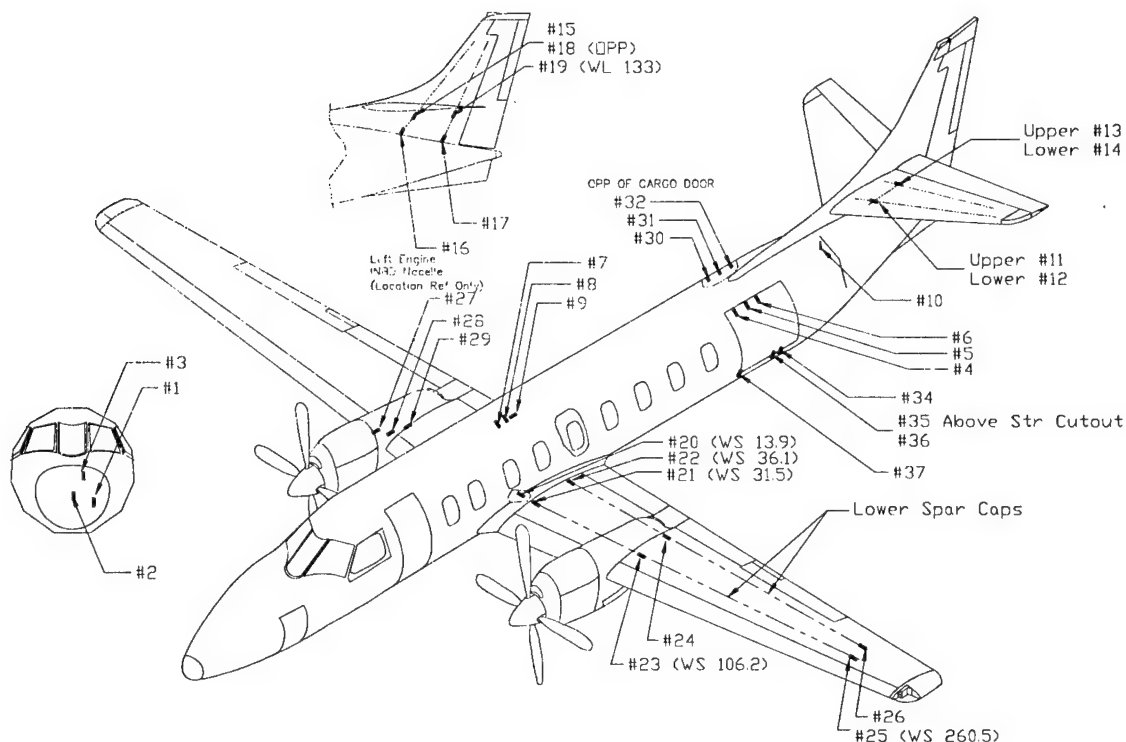
FIGURE 3. STRAIN GAGE LOCATIONS

In support of the SID program, an SA227-DC aircraft was instrumented to measure strains at numerous locations during typical flight maneuvers. The details and results of these flight tests were reported at length in reference 3. Figure 3 shows the strain gage locations.

Figure 3 in section 2.2.2.1 showed the locations of strain gages used to measure stresses on the aircraft during typical flight maneuvers. This data was used to help transform flight loads to stresses at critical areas of the principal structural elements. Further discussion of the methods and results of the strain survey is available in reference 3.

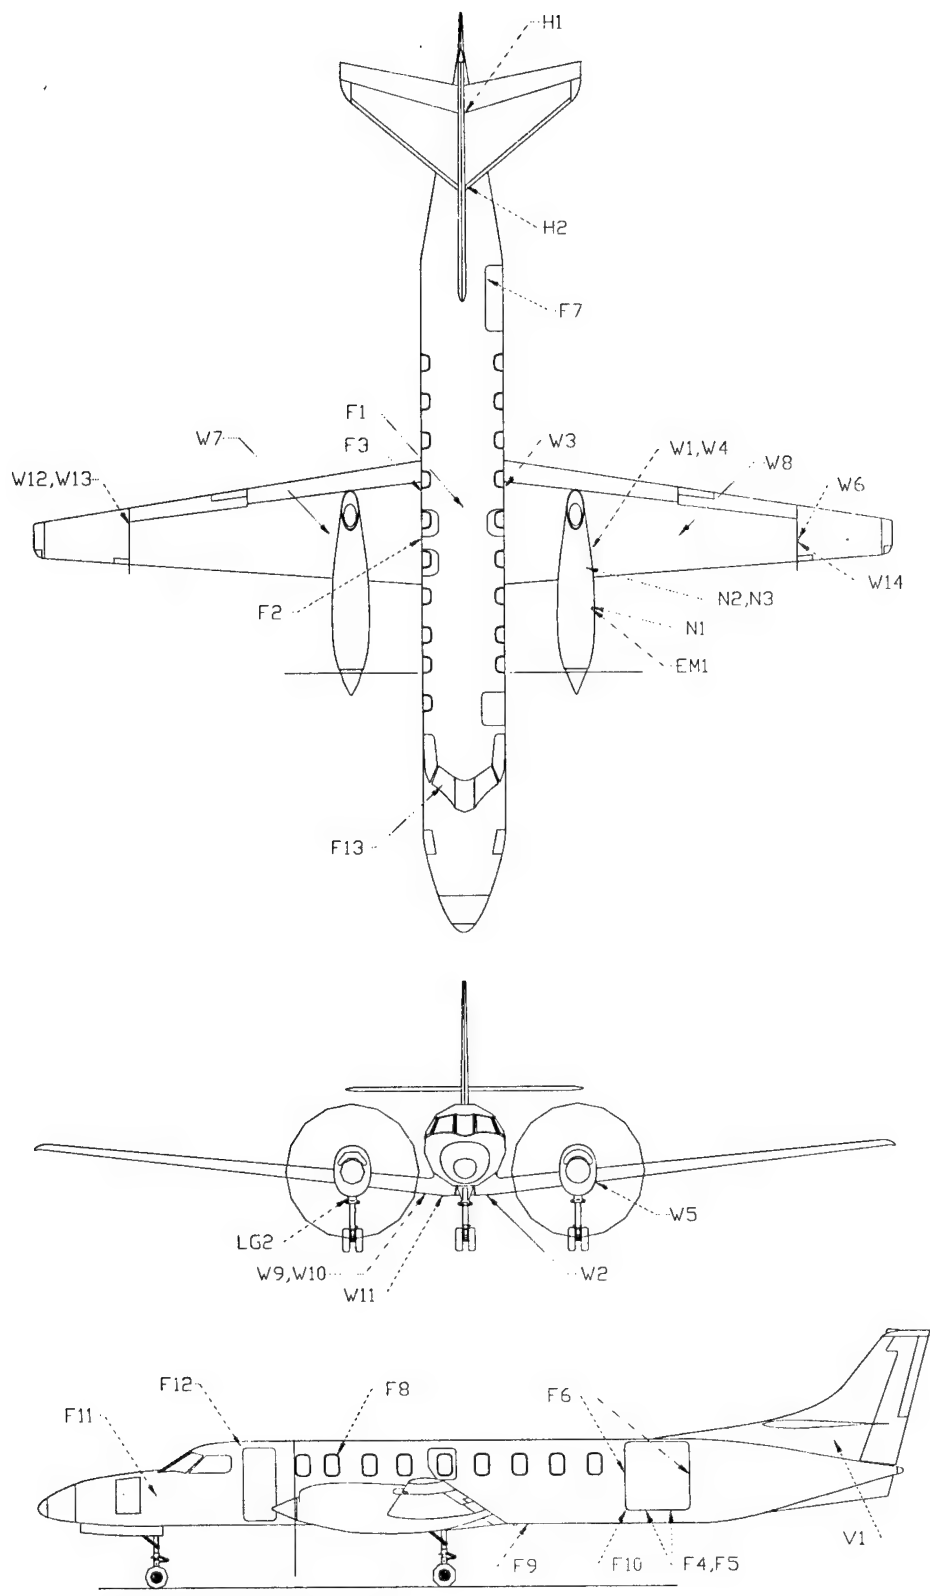
FIGURE 4. LOCATIONS OF CRITICAL AREAS

Table 4 presents the PSE critical areas selected for damage tolerance analysis. Figure 4 shows the locations of the critical areas. They are also depicted in reference 3.

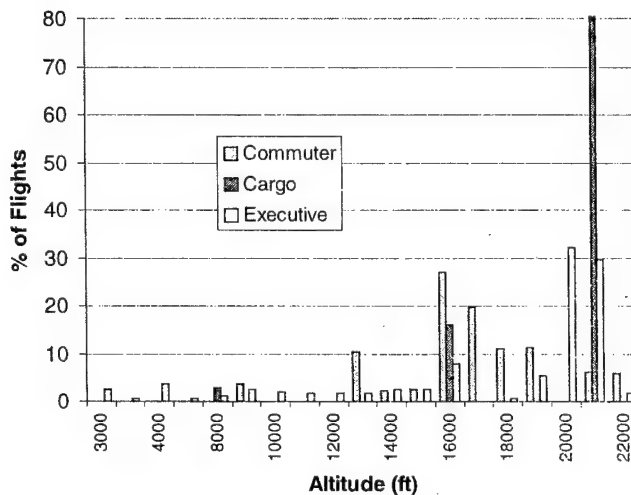
FIGURE 5. CRUISE ALTITUDE FREQUENCIES

The surveys covered a total of 70 aircraft and 871 flights: 32 aircraft and 535 flights with two commuter operators, 31 aircraft and 248 flights with a cargo operator, and 7 aircraft and 190 flights with an executive operator. Table 5 and figures 5 and 6 summarize the findings of the surveys. The complete set of data is provided in reference 3.

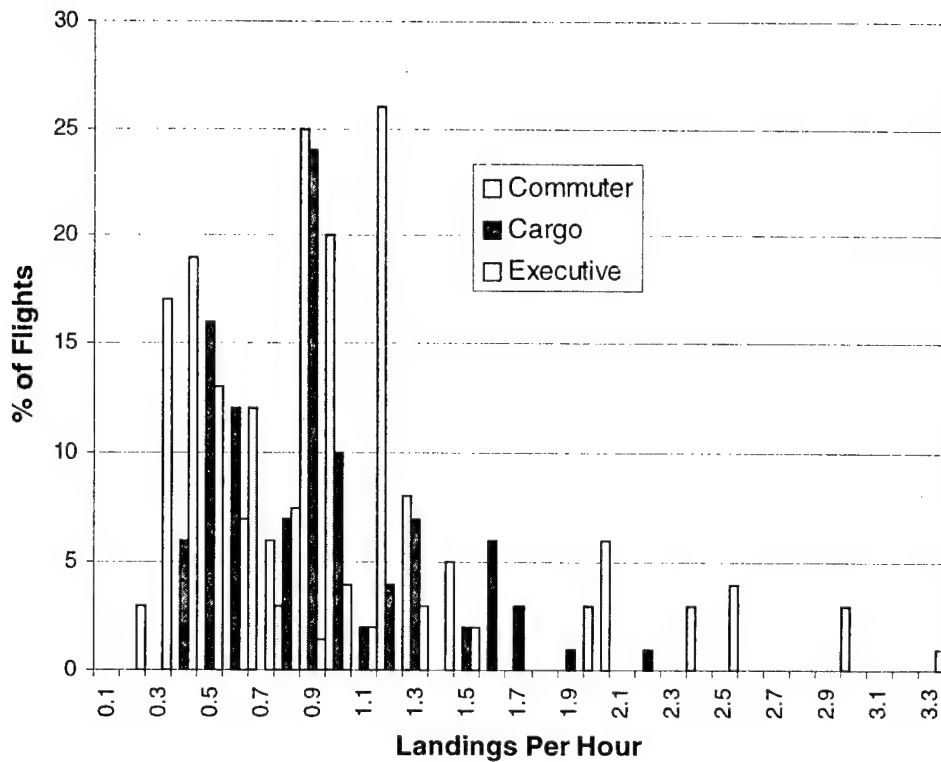
FIGURE 6. LANDINGS PER HOUR DISTRIBUTION

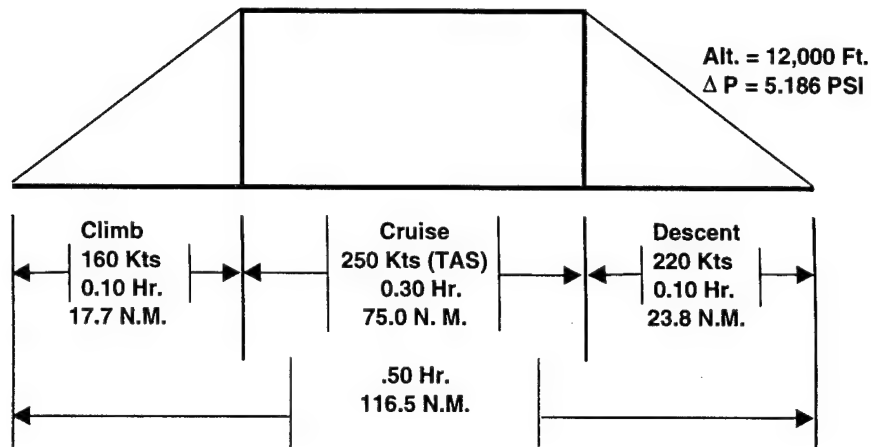
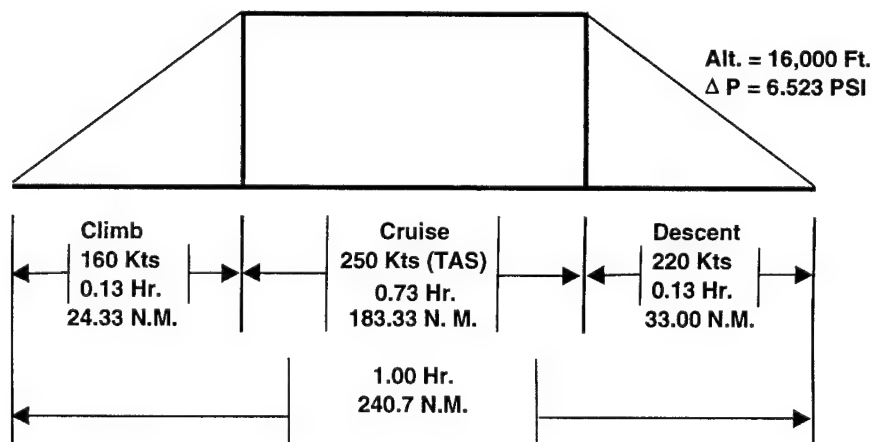
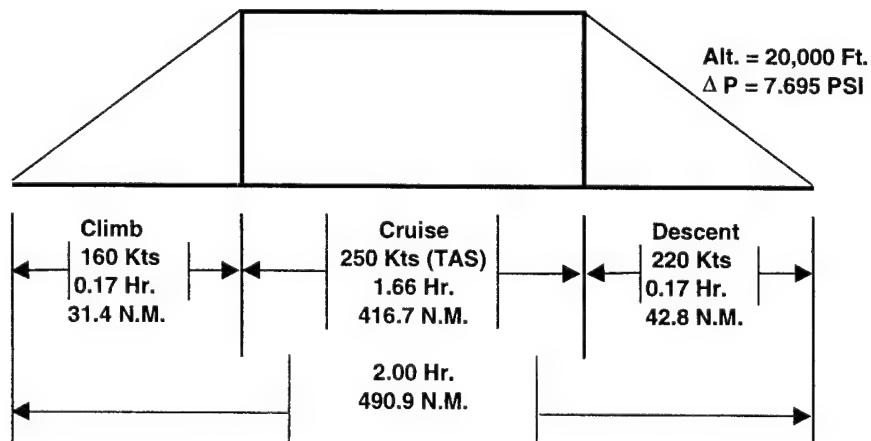
FLIGHT PROFILE - COMMUTER

FLIGHT PROFILE - CARGO

FLIGHT PROFILE - EXECUTIVE

FIGURE 7. SA227 FLIGHT PROFILES

After reviewing the flight length, cruise altitude, and takeoff weight data of surveyed aircraft, three profiles were developed to represent flights typical of the three types of operation (commuter, cargo, executive). Table 6 shows the mission parameters and figure 7 illustrates the flight profiles.

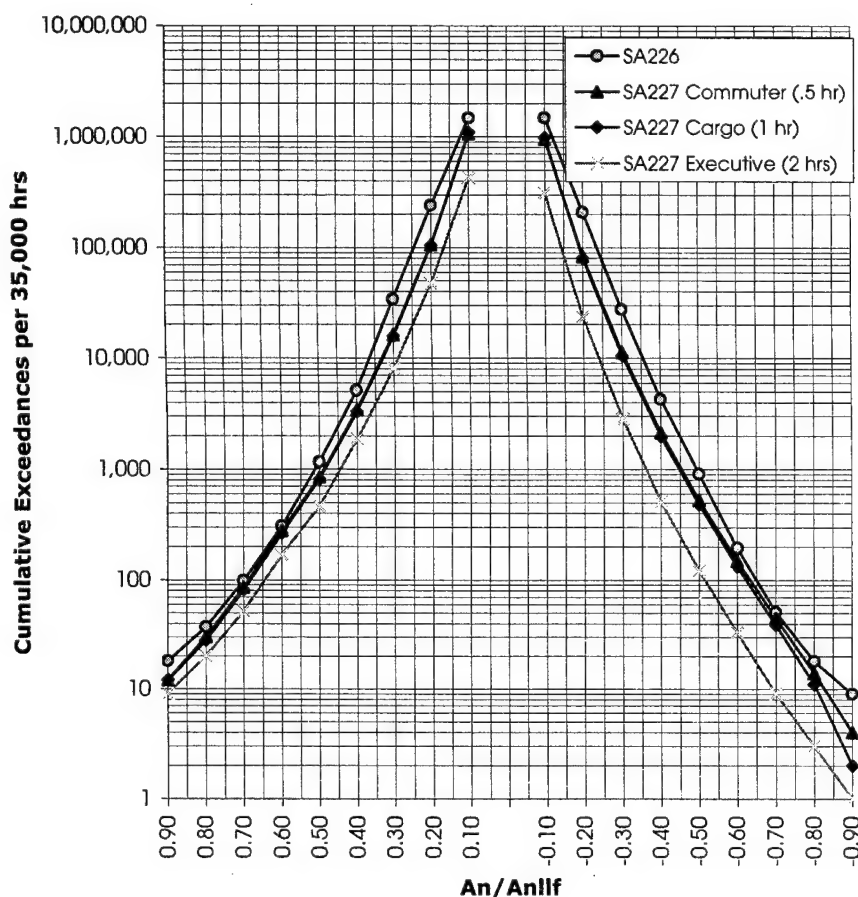
FIGURE 8. GUST AND MANEUVER LOAD SPECTRA

Figure 8 shows the gust and maneuver load spectra for the SA226 and each of the three SA227 mission profiles.

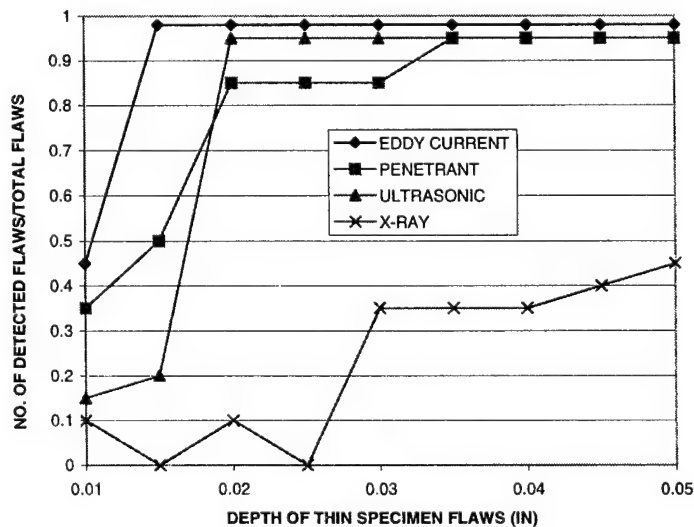
FIGURE 9. SAMPLE CRACK DETECTION PROBABILITY CURVES

Figure 9, reproduced from reference 12 page 4-85, shows probability of detection for uncovered flaws in thin aluminum. Table 11 lists quoted minimum detectable crack sizes from specific installations in the Cessna 402 [13]. Reference 14 gives the following formula for detectable crack size of surface eddy-current probes: Detectable Crack Length = (Fastener Head DIA - Fastener Shank DIA) / 2 + Coil DIA

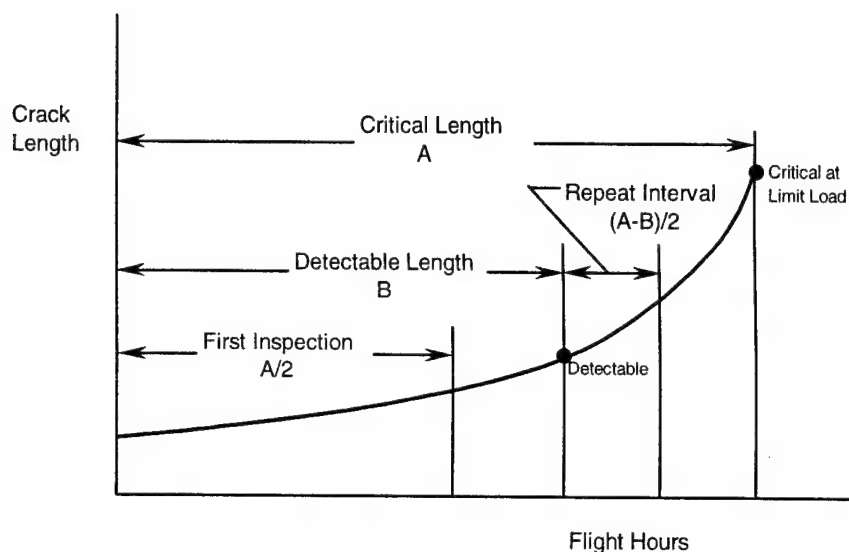
FIGURE 10. INSPECTION INTERVAL AND CRACK GROWTH CURVE RELATIONSHIP

The recommended repeat inspection intervals for each PSE are presented in the SA226 and SA227 SID [16]. Figure 10 summarizes how the inspection intervals were obtained based on crack growth analysis. Scatter factors of 2 are assumed.

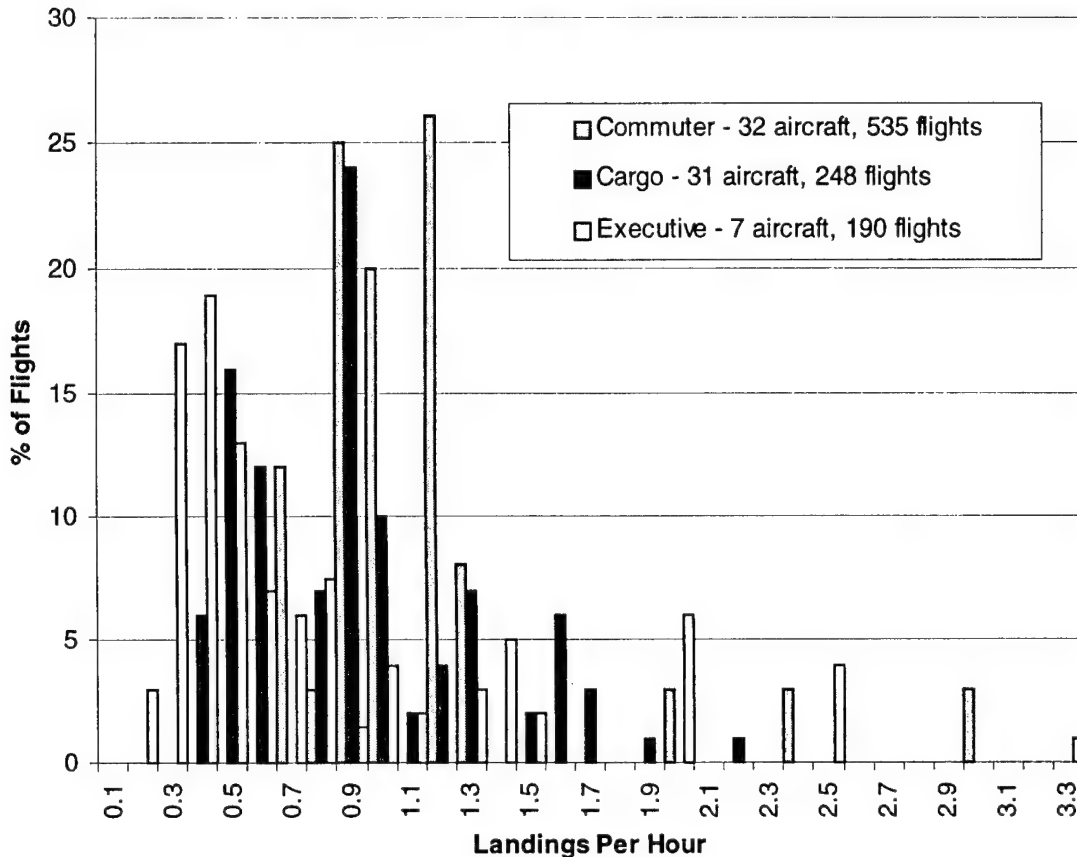
Figure 1. Flight Length Summary (Sheet 1)

Additional information was gathered from the Official Airline Guide and teleconferences with operators. A graphical summary of the usage data from the survey is shown in Figure 1.

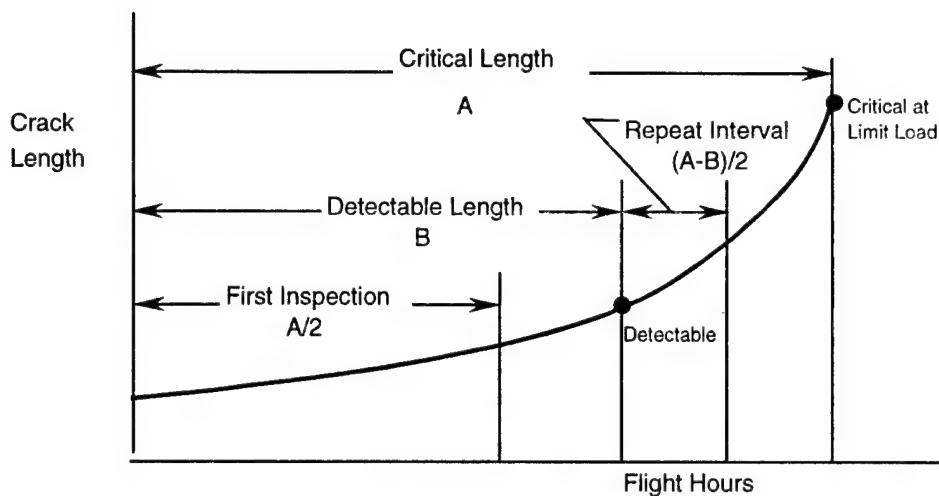
Figure 2. Typical Crack Growth Curve

Initial inspections were based on the shorter of analytical crack growth curves, fatigue test results, or service experience. Where analytical crack growth was used, the initial inspection was set at $c_{crit}/2$, where c_{crit} is the crack size at which the structure can no longer support limit load. The initial crack size was assumed to be 0.05 inch in most cases. Figure 2 shows a typical crack growth curve and the inspection intervals determined therefrom.

A very important part of the SID program is selecting and evaluating state-of-the-art nondestructive inspection (NDI) methods applicable to each PSE and determining a minimum detectable cracks length, c_{det} , for each NDI method. The minimum detectable crack length is used in conjunction with the critical crack length, c_{crit} , to define the life interval for the crack to grow from c_{det} to c_{crit} . This interval, $(c_{crit} - c_{det})/2$, is used to define the repeat inspection frequency for the SID program's required inspections. The threshold inspection generally occurs at $c_{crit}/2$. For a given NDI method and PSE, c_{det} corresponds to a crack size with 90% probability of detection. An example of repeat and initial inspection interval determination is shown in Figure 2.

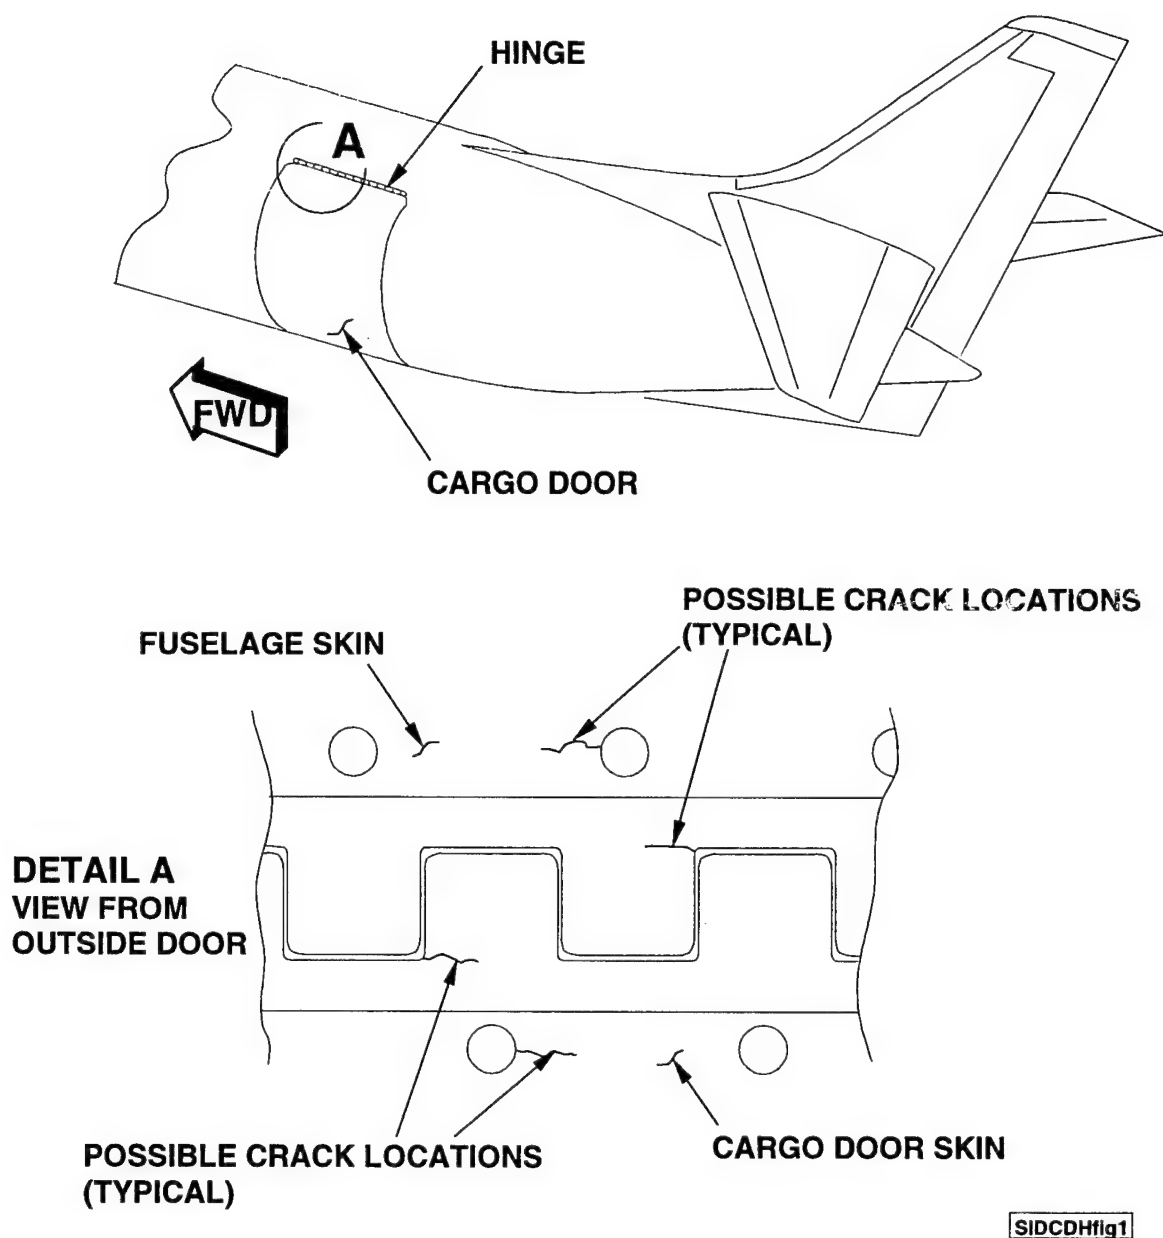
Figure 1. SA226/SA227 Cargo Door Hinge

1. Adhere to procedures for Eddy-Current Inspection given in the SA226/227/227CC Structural Repair Manual, Chapter 51-30-07.
2. Refer to Figure 1. Inspect the hinge tabs and around fastener holes along the length of the hinge. Inspect the top piece (on fuselage) and bottom piece (on cargo door). Observe the phase and amplitude changes on the instrument.
3. Cracks are most likely to occur near the ends of the hinge.
4. If an indication is noted, carefully repeat the inspection pass in the opposite direction to verify the indication.
5. All cracks detected shall be reported to Fairchild Service Engineering. Report the location, direction, and length of each crack.

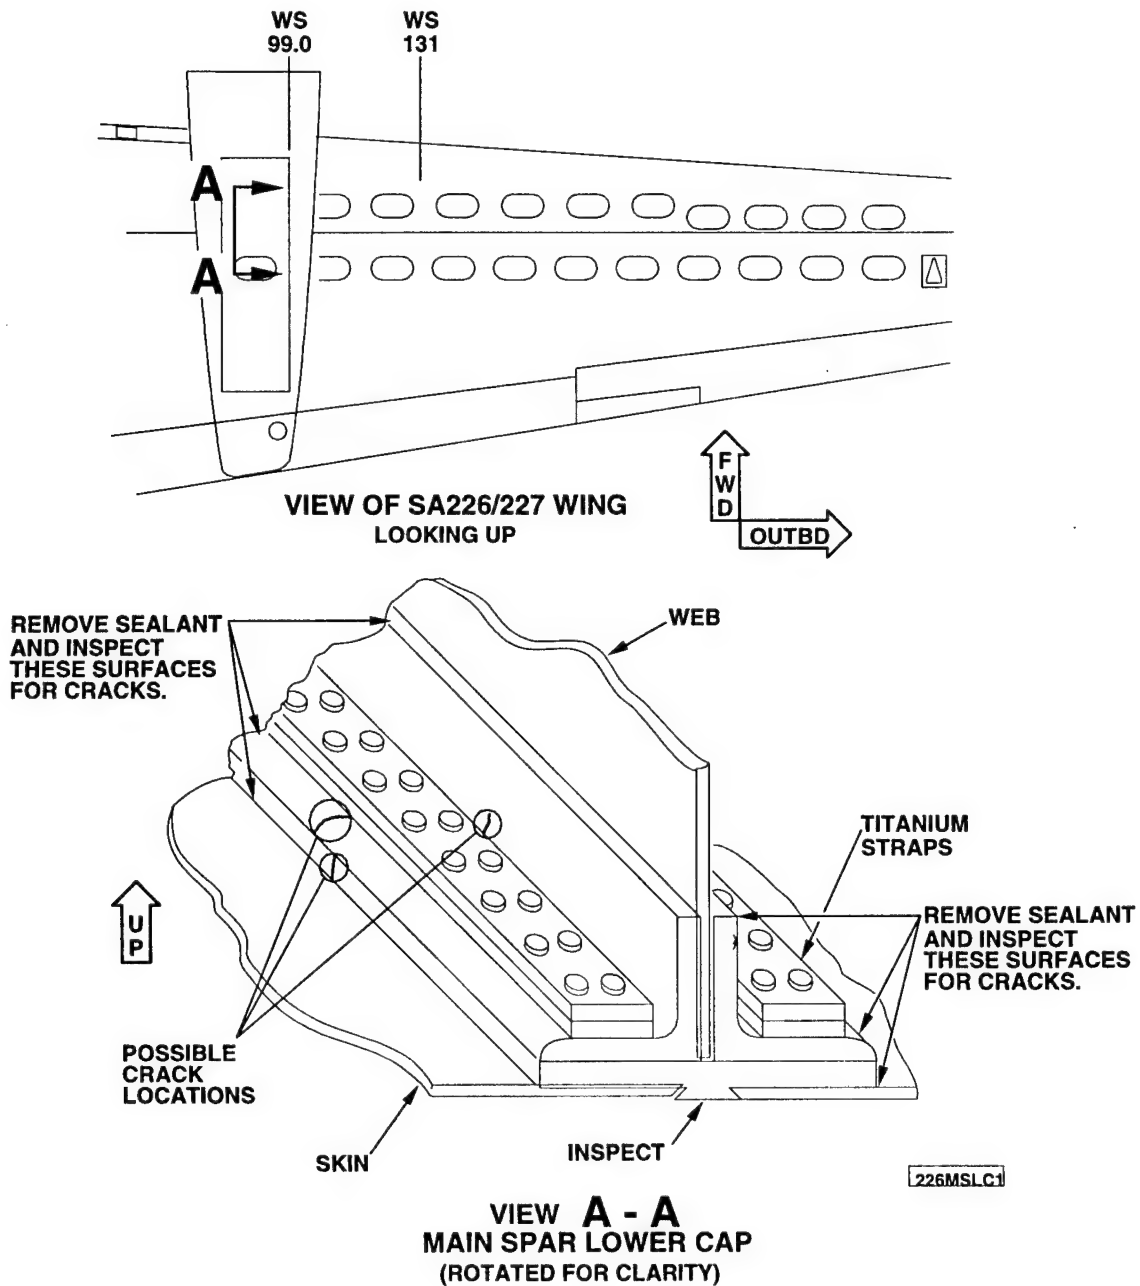
FIGURE 1. SA226/227 WING MAIN SPAR LOWER CAP WS 99

6. If an indication is noted, carefully repeat the inspection pass in the opposite direction to verify the indication.
7. All cracks detected shall be reported to Fairchild Service Engineering. Report the location, direction, and length of each crack.

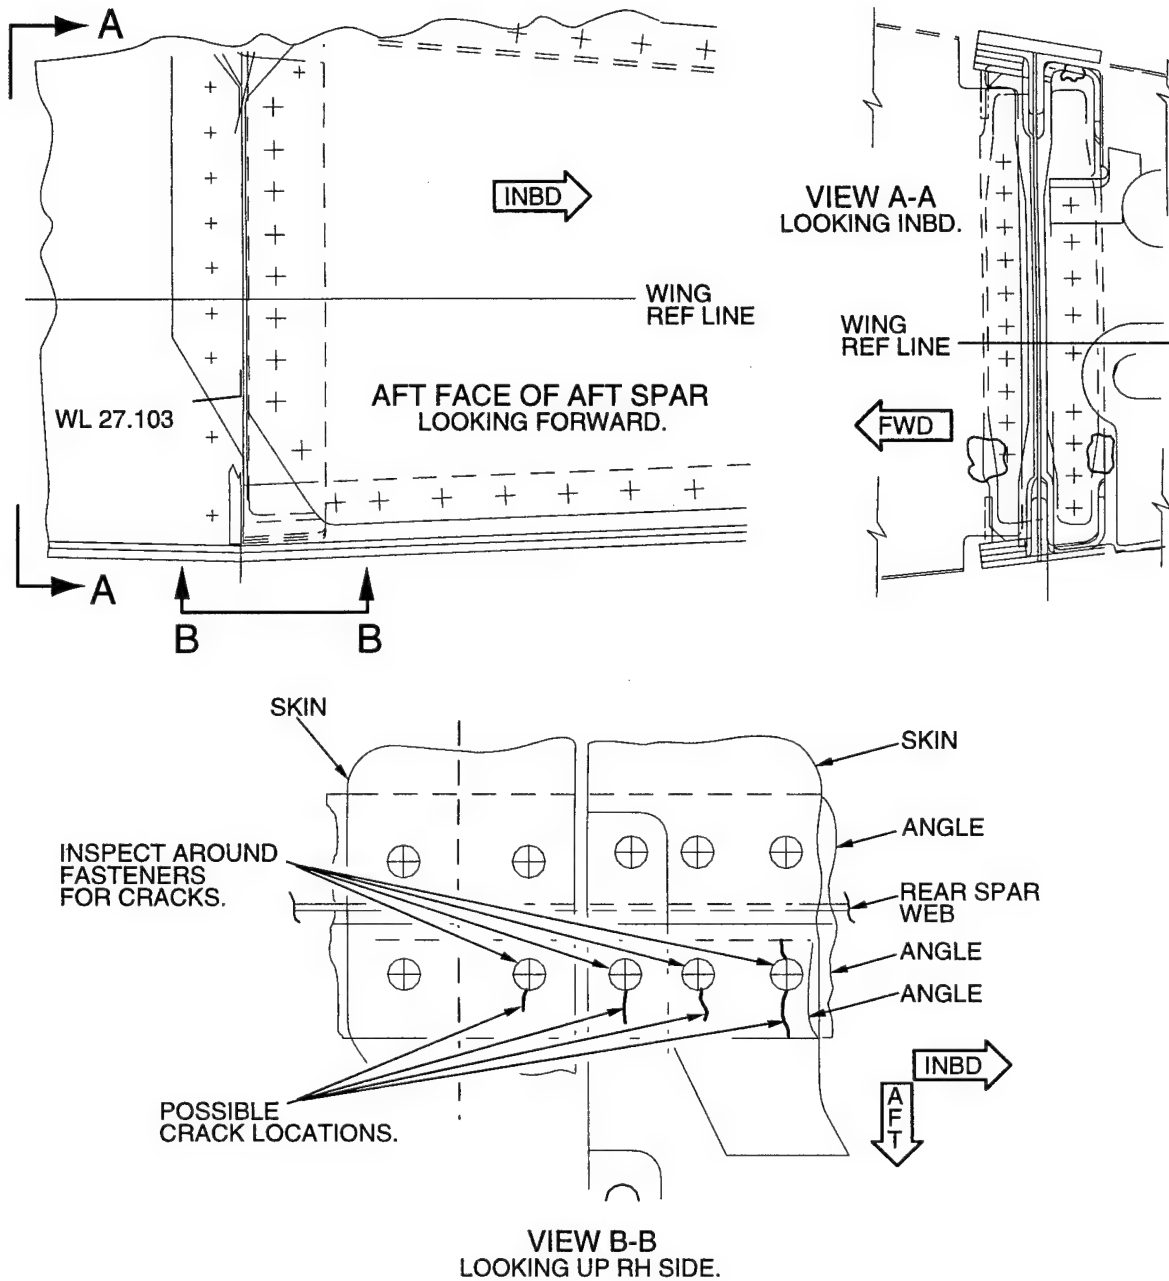
226RSLC1

SA226 WING REAR SPAR LOWER CAP AT WS 27
 FIGURE 1

1. Adhere to procedures for Eddy-Current Inspection given in the SA226/227 Structural Repair Manual, Chapter 51-30-07.
2. Refer to Figure 1. Inspect aft aluminum spar cap angle around the fastener holes between stations 24 and 27, left and right wing. Observe the phase and amplitude changes on the instrument.
3. If an indication is noted, carefully repeat the inspection pass in the opposite direction to verify the indication.
4. All cracks detected shall be reported to Fairchild Service Engineering. Report the location, direction, and length of each crack.

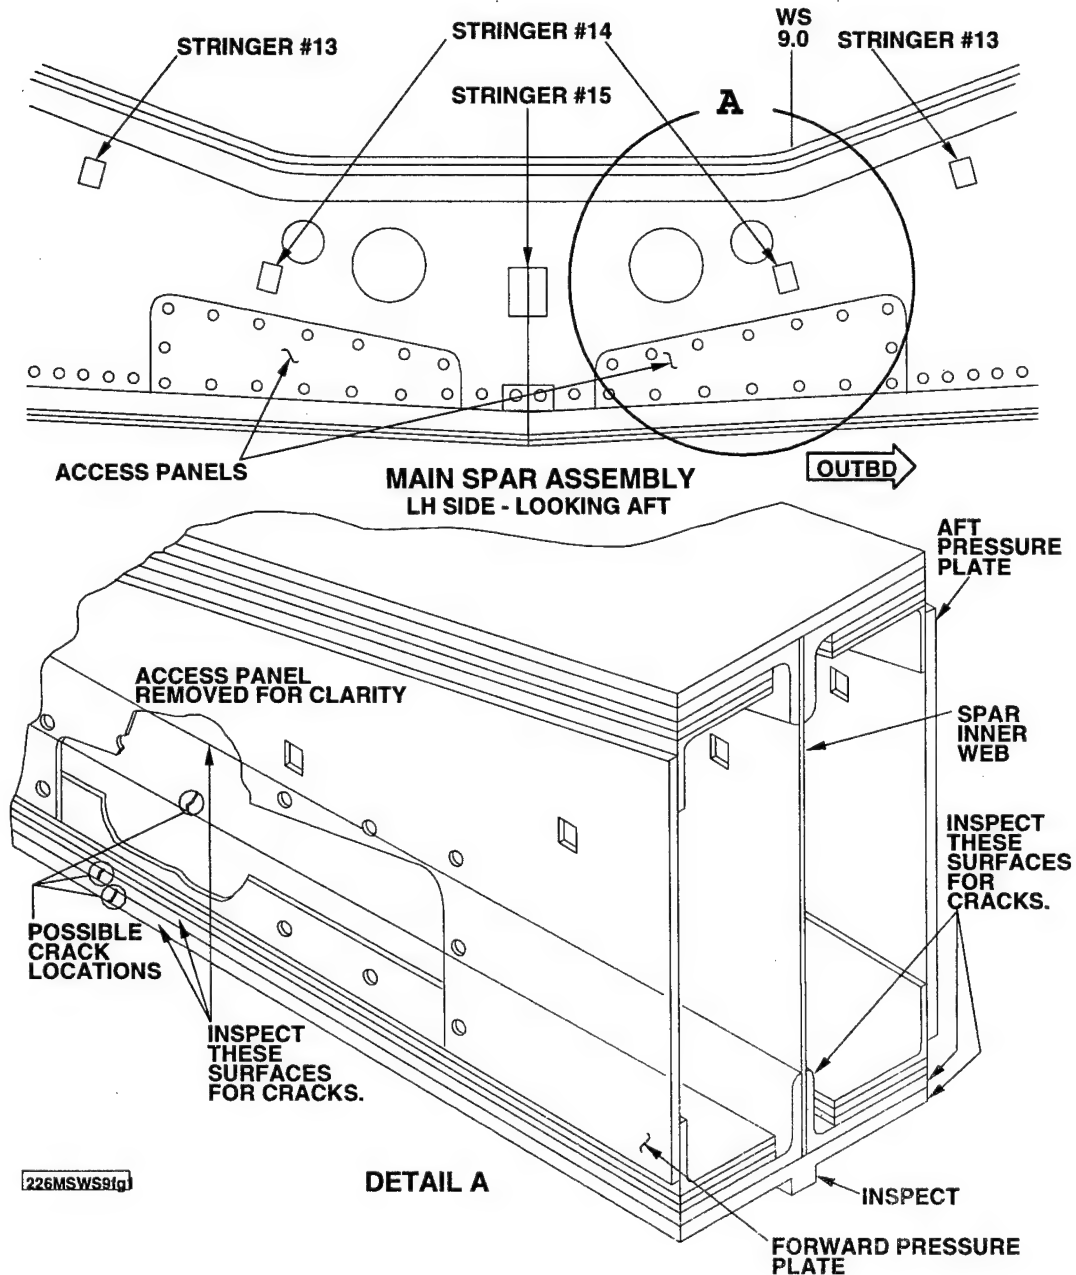
Figure 1. SA226 Main Spar at WS 9.0

5. Detection of a crack may indicate complete failure of the part.
6. If an indication is noted, carefully repeat the inspection pass in the opposite direction to verify the indication.
7. All cracks detected shall be reported to Fairchild Service Engineering. Report the location, direction, and length of each crack.

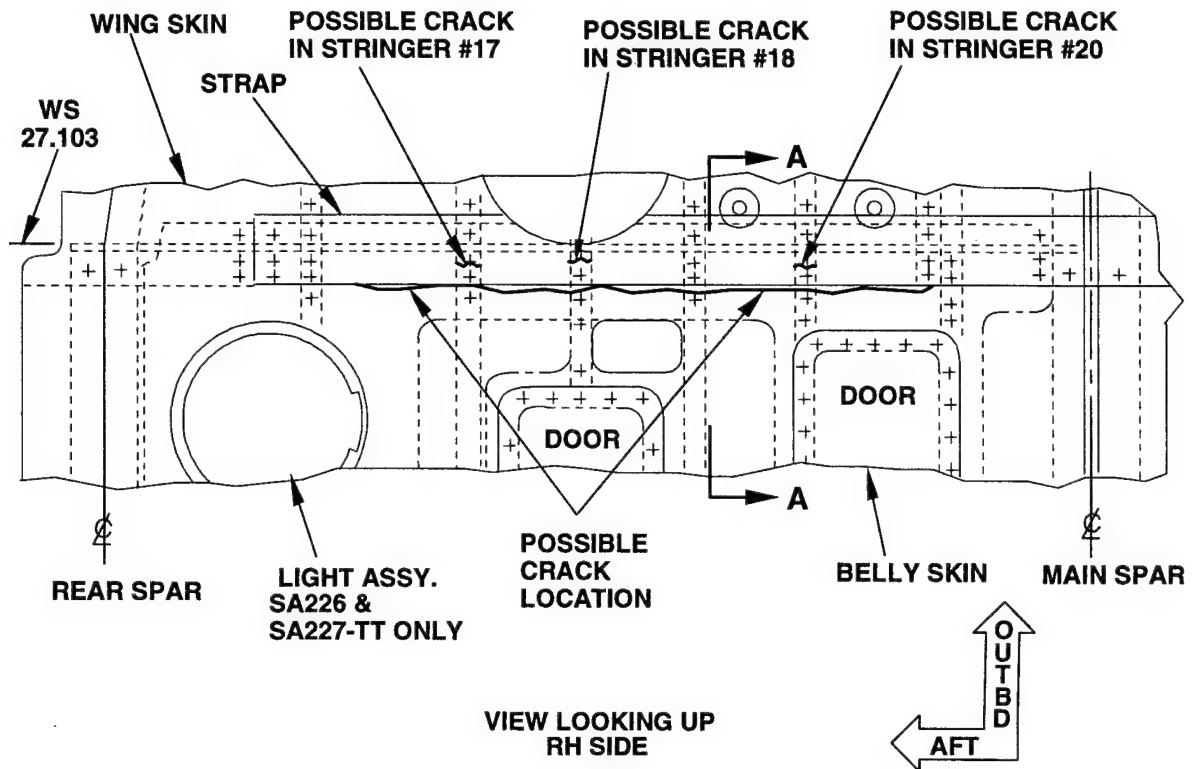
SIDws27t1-1

Figure 1. SA226/SA227 Lower Wing Skin Splice at WS 27 (Sheet 1)

1. Adhere to procedures for Eddy-Current Inspection given in the SA226/227 Structural Repair Manual, Chapter 51-30-07.
2. Refer to Figure 1, Sheets 1 and 2. Inspect the outside surface of the belly skin just inboard of the splice strap at WS 27, left and right side, from main spar to rear spar.
3. Inspect the inside surface of the belly skin around the fastener holes in the splice just inboard of WS 27, left and right side, from main spar to rear spar. Refer to Figure 1, Sheet 2.
4. Inspect stringers 16 through 21 around the fastener holes just inboard of the rib at WS 27, left and right side. Refer to Figure 1, Sheets 1 and 2.
5. If an indication is noted, carefully repeat the inspection pass in the opposite direction to verify the indication.
6. All cracks detected shall be reported to Fairchild Service Engineering. Report the location, direction, and length of each crack.

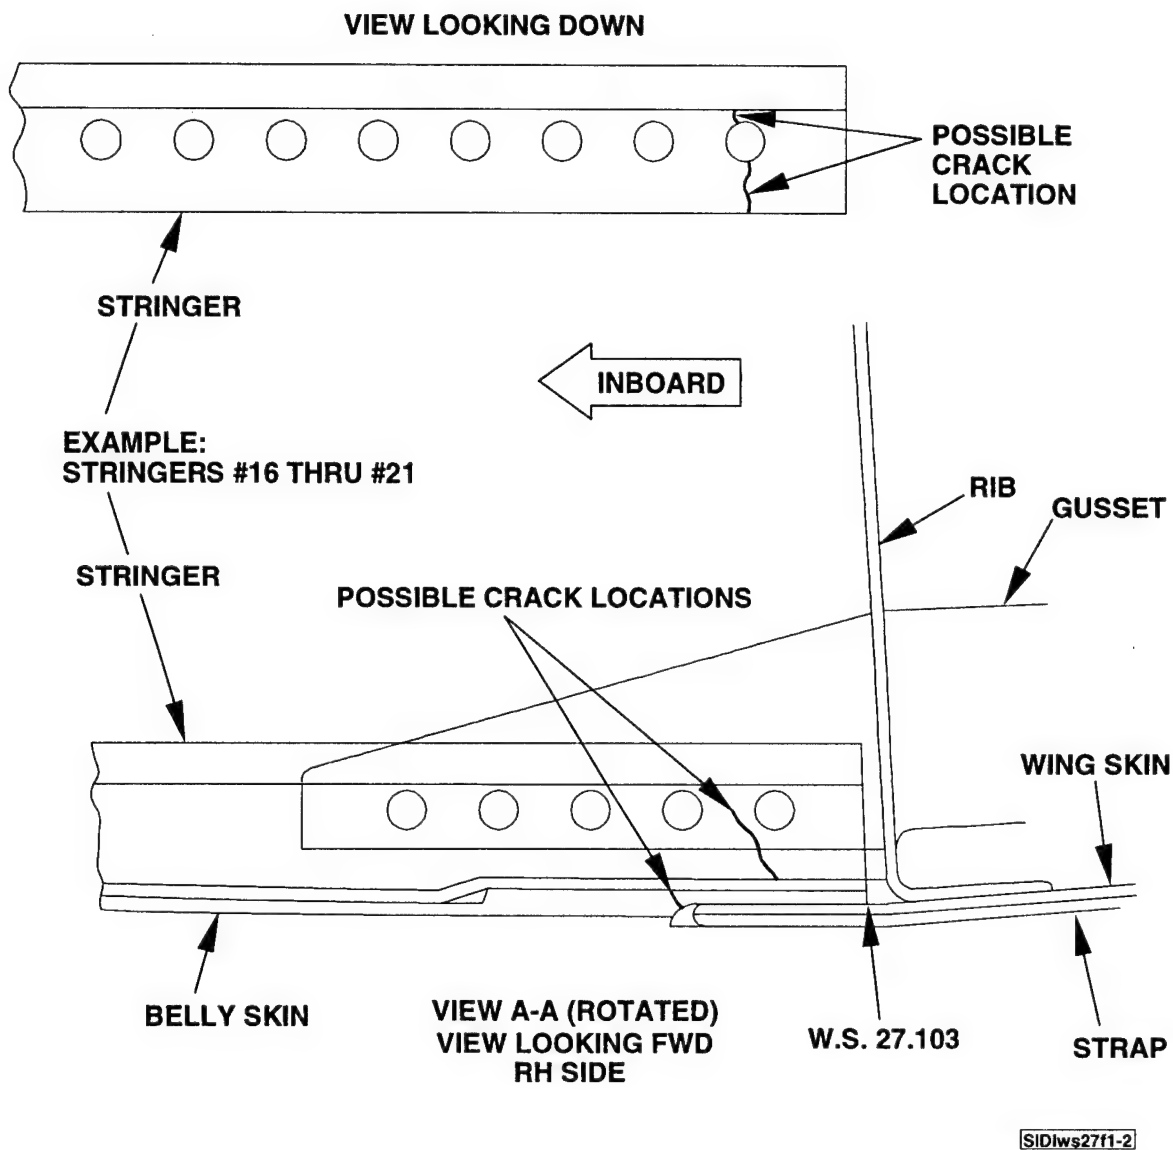
Figure 1. SA226/SA227 Lower Wing Skin Splice at WS 27 (Sheet 2)

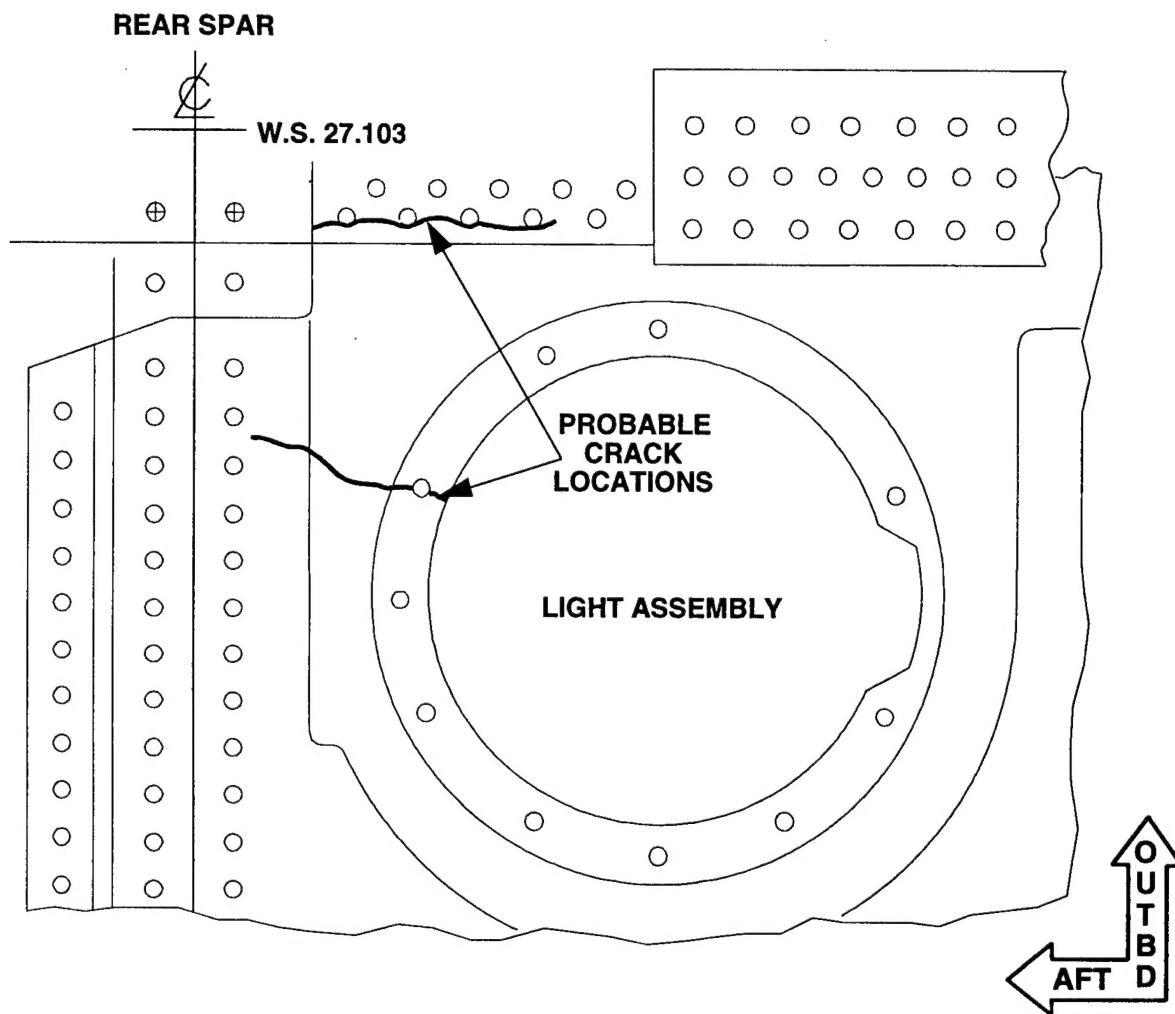
SID226WLCf1

Figure 1. SA226/SA227 Wing Center Section Skin at Landing Light Cutout

1. Adhere to procedures for Eddy-Current Inspection given in the SA226/227 Structural Repair Manual, Chapter 51-30-07.
2. Refer to Figure 1. Inspect belly skin around landing light cutout and at splice of belly skin to center wing skin. Observe the phase and amplitude changes on the instrument.
3. If an indication is noted, carefully repeat the inspection pass in the opposite direction to verify the indication.
4. All cracks detected shall be reported to Fairchild Field Support Engineering. Report the location, direction, and length of each crack.

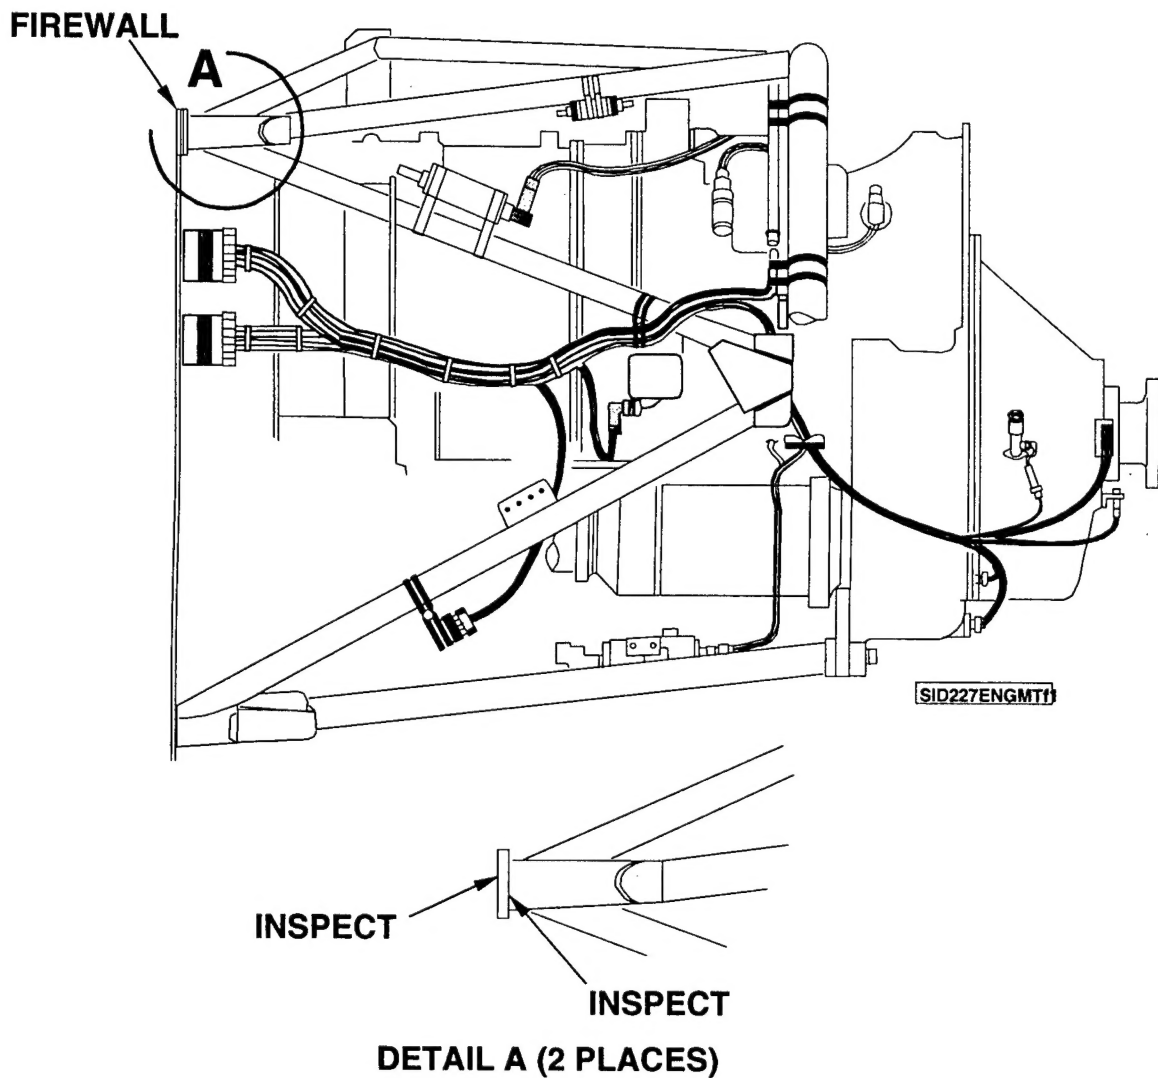
Figure 1. SA227 Engine Mount at Firewall
